This file is for the weir boxes that are measuring drain and overland flow in the bowl. They were installed on 01/11/06.

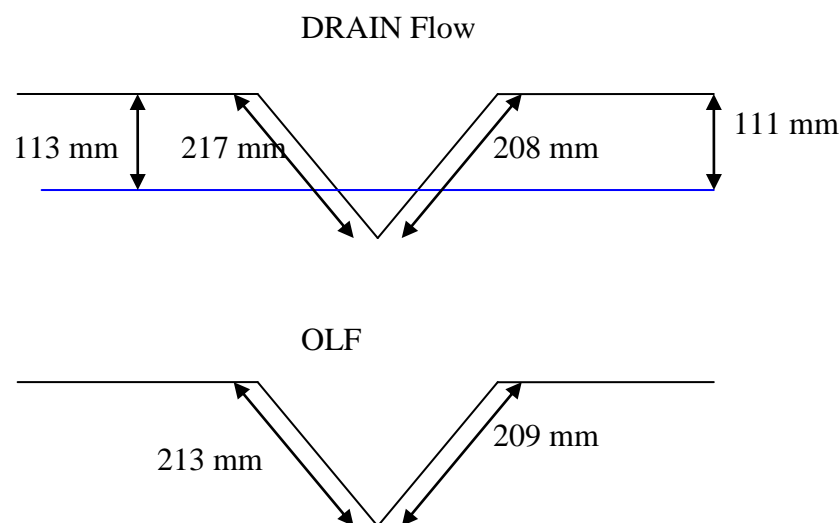
Diagrams below show measurements taken of the v-notch and the water status of at least the DRAIN flow box. For the drain flow box there is a 9 mm difference in the length of the V on either side suggesting that the v is not completely vertical. The average length is 212.5 mm. The CV is 2.99 %. The average length of the OLF is 211 mm. The CV is 1.3 %.

Measurements of water depth of the drain flow were taken at the time of download. These figures were taken at the edge of the box, away from the V-notch to avoid the effects of the draw down. Average 112 mm. Using the average length of V-side the depth of water above the V-notch was 37.3 mm
