## **Landslide Hazard Parameters**

The landslide parameters were identified based on the observations and surveys summarised below.

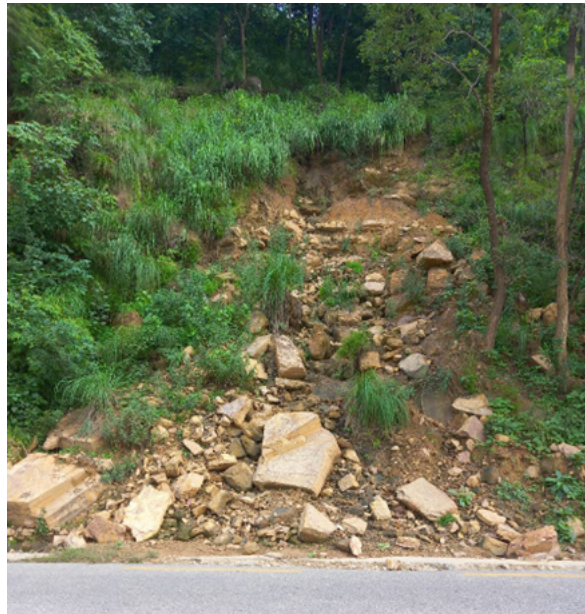
### ***Landslide 1***

Type: Debris Flow

Slope: 64 degrees

Deposition depth: 1.2m

Volume= 210.02m<sup>3</sup>

Deposited materials: mud, debris, rocks of sizes up to 0.4m

Impacts: Temporary obstruction of the road

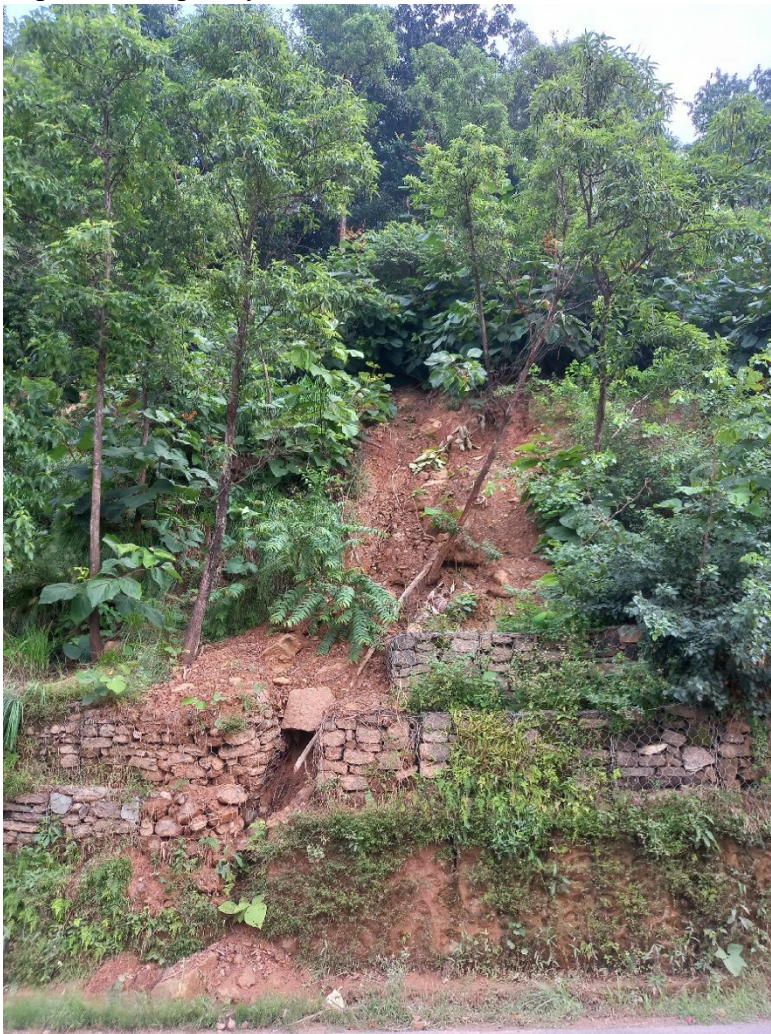
### ***Landslide 2***

Type: Debris Flow

Slope: 62 degrees

Occurrence: 2022 monsoon; retaining structure built to manage the landslide (local interview)

Volume= 118.144 m<sup>3</sup>

Deposited materials: mud, debris

Impacts: Temporary obstruction of the road

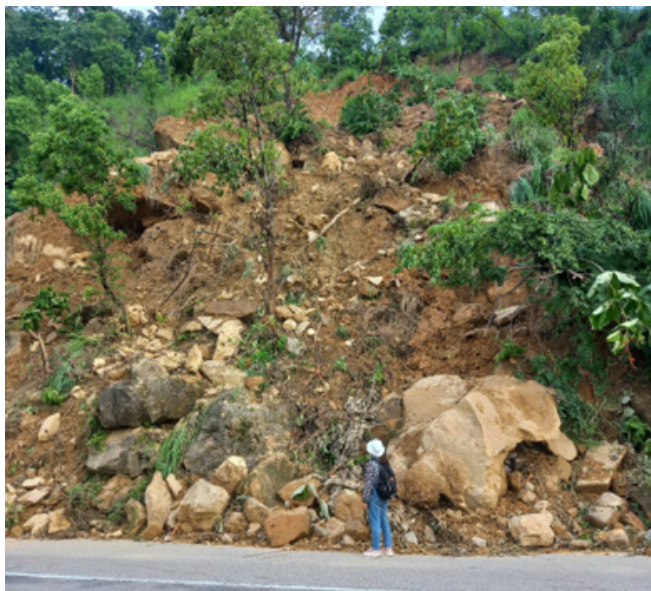
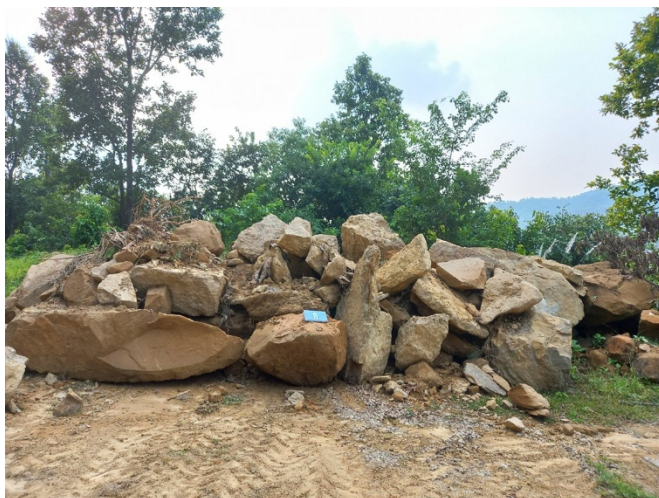
### ***Landslide 3***

Type: Translational slide

Slope: 59 degrees

Occurrence: 2023 October; very recent (local interview)

Volume= 590m<sup>3</sup>

Deposited materials: mud, debris, rocks of sizes up to 1.6m

Impacts: Temporary obstruction of the road; local people and police had to remove the fallen rocks

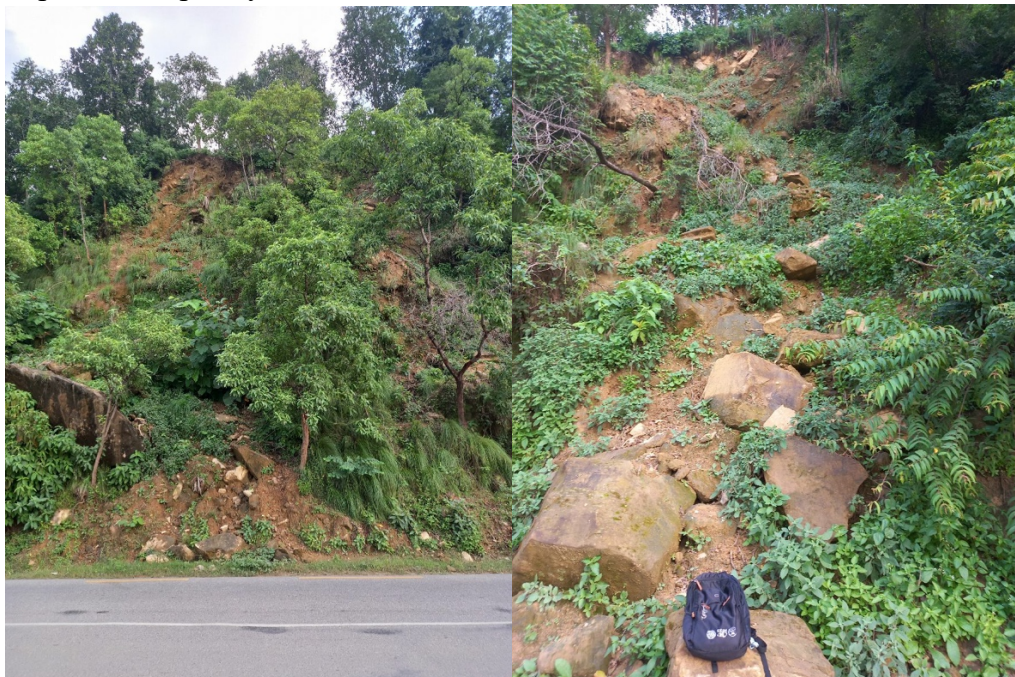
#### ***Landslide 4***

Type: Debris Flow

Slope: 64 degrees

Volume= 560.7m<sup>3</sup>

Deposited materials: mud, debris, rocks of sizes up to 0.6m

Impacts: Temporary obstruction of the road

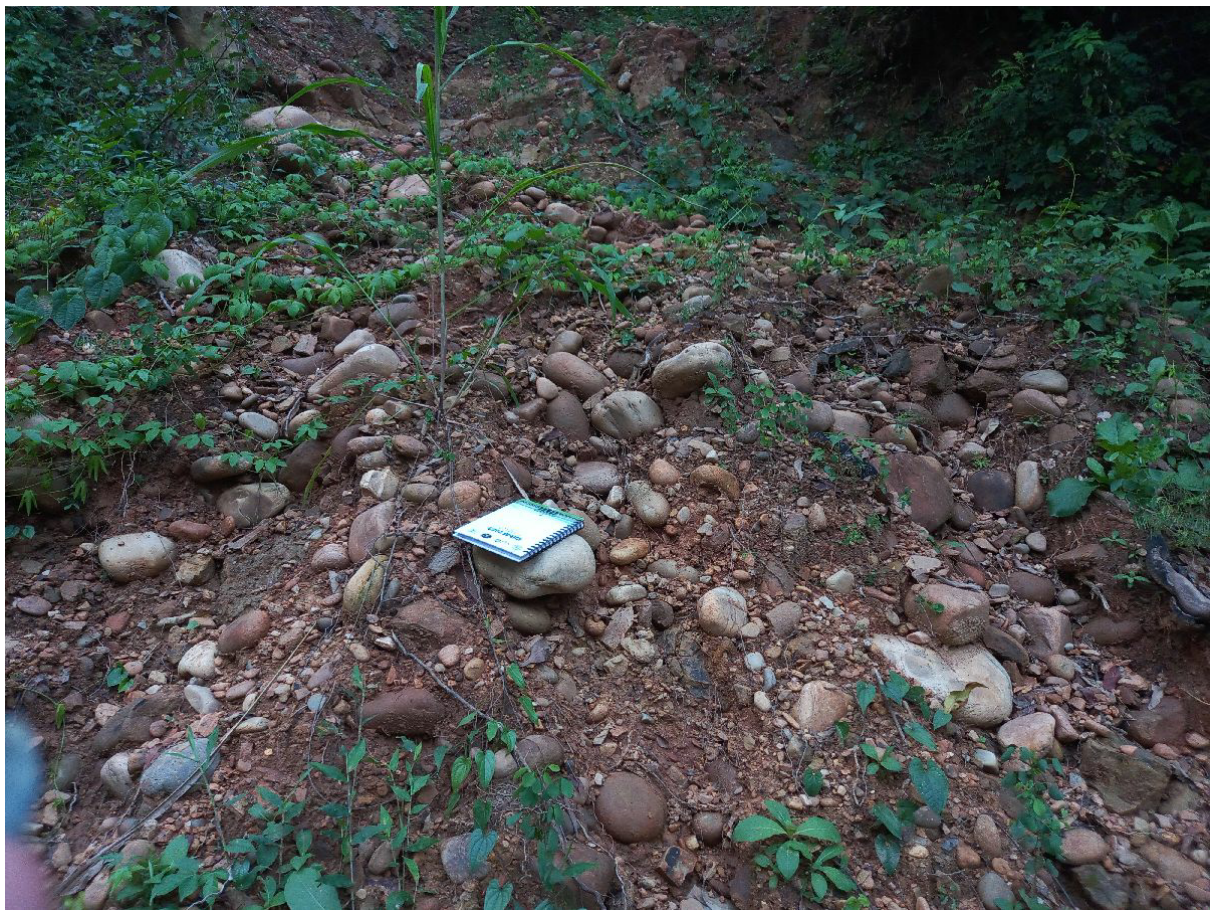
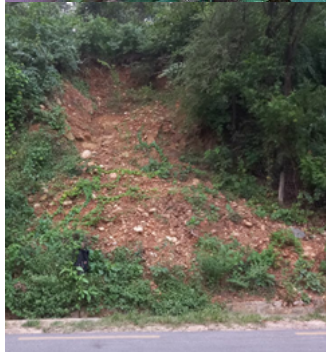
### ***Landslide 5***

Type: Debris Flow

Slope: 54 degrees

Volume= 187.136m<sup>3</sup>

Deposited materials: mud, debris, rocks of sizes up to 0.25m

Impacts: No significant impacts

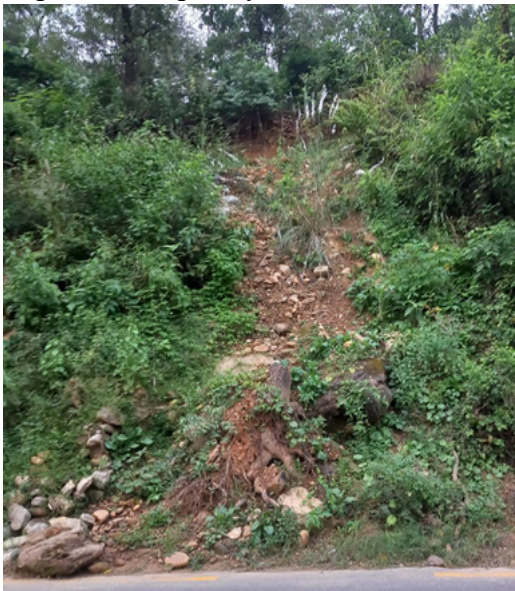
### ***Landslide 7***

Type: Debris Flow

Slope: 60 degrees

Volume= 229.6m<sup>3</sup>

Deposited materials: mud, debris, rocks of sizes up to 0.6m

Impacts: Temporary obstruction of the road

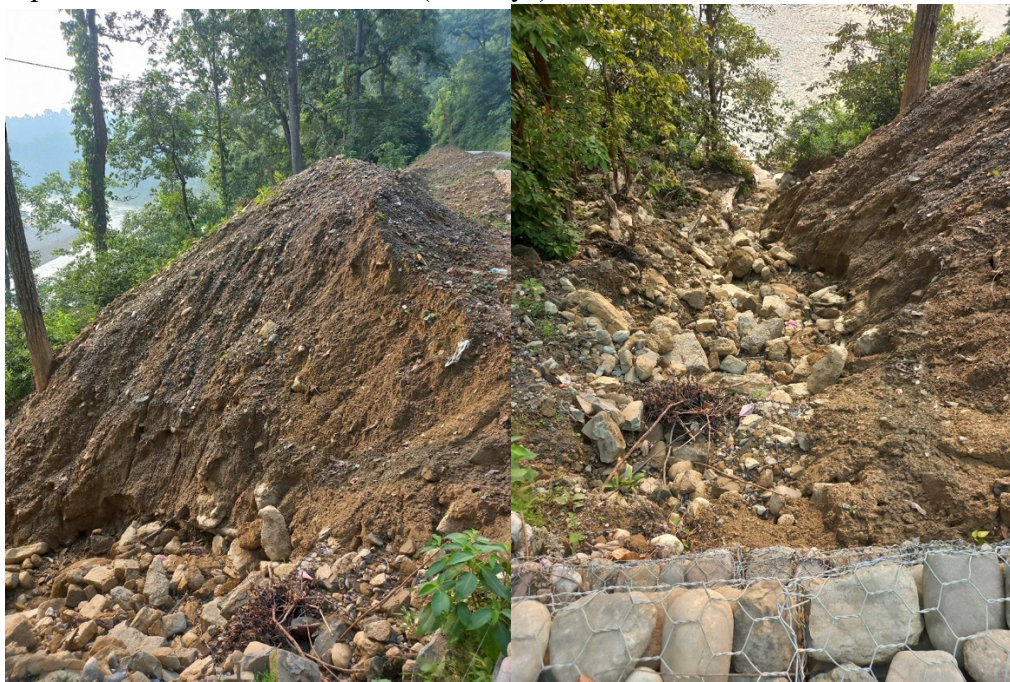
### ***Landslide 8***

Type: Debris Flow

Occurrence: 2023 monsoon, some days after Dashain; retaining structures built after the landslide (local interview)

Volume= 2823.4m<sup>3</sup>

Deposited materials: mud, debris, rocks of sizes up to 0.15m

Impacts: Obstruction of the road (6-7 days)

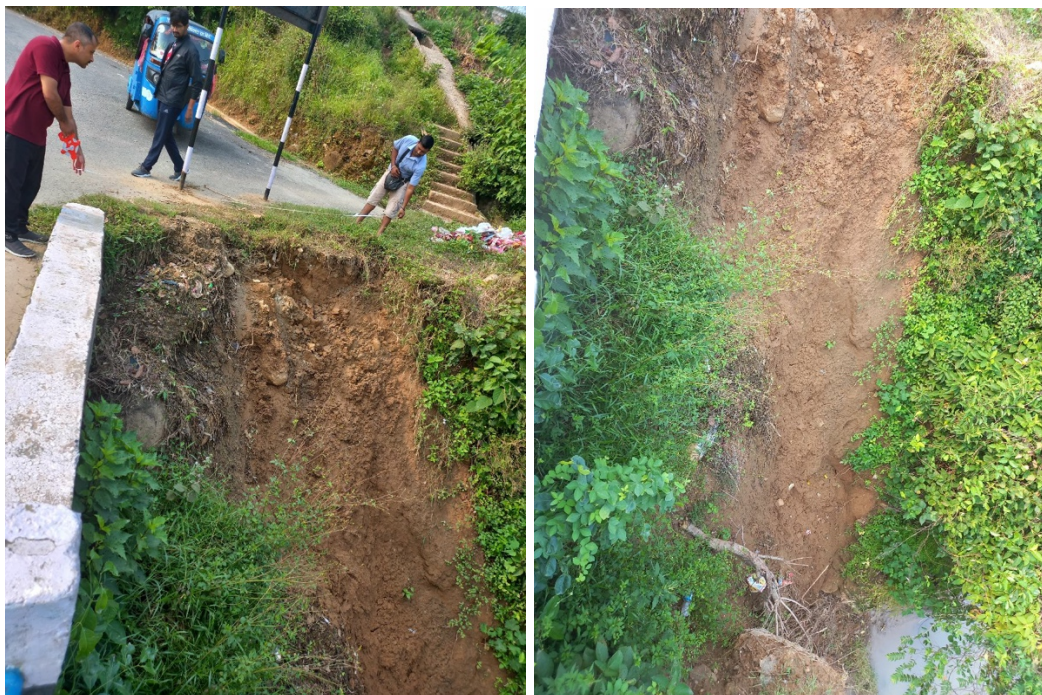
### ***Landslide 9***

Type: Debris Flow

Slope: 62 degrees

Volume= 79.2m<sup>3</sup>

Deposited materials: primarily mud, debris

Impacts: No significant impacts

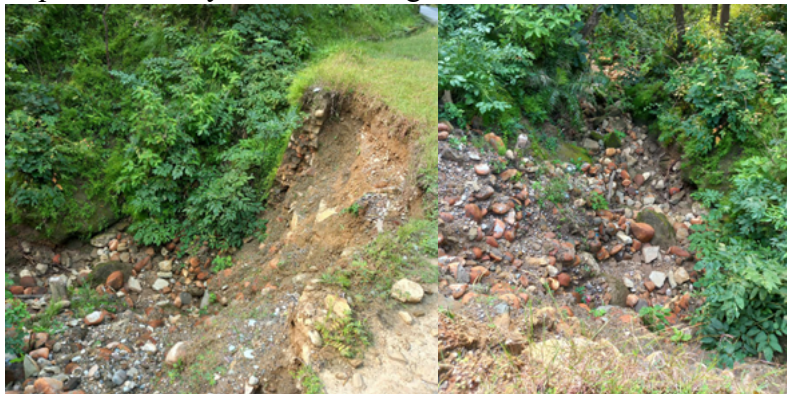
### ***Landslide 10***

Type: Debris Flow

Occurrence: 2023 monsoon, repeatedly occurs every year during extreme rainfall events (local interview)

Volume= 295.848m<sup>3</sup>

Deposited materials: mud, debris, rocks of sizes up to 0.1m

Impacts: Destroyed the retaining wall due to extreme rainfall event this year and last year

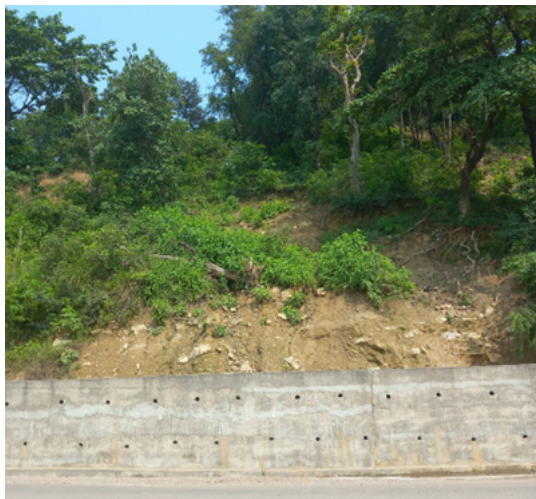
### ***Landslide 11***

Type: Translational slide

Slope: 48 degrees

Volume= 1999.2m<sup>3</sup>

Deposited materials: NA; landslide managed by local community and police

Impacts: Road blocked for 1 whole day, disrupting traffic. Retaining structure built after the landslide which has managed the impacts

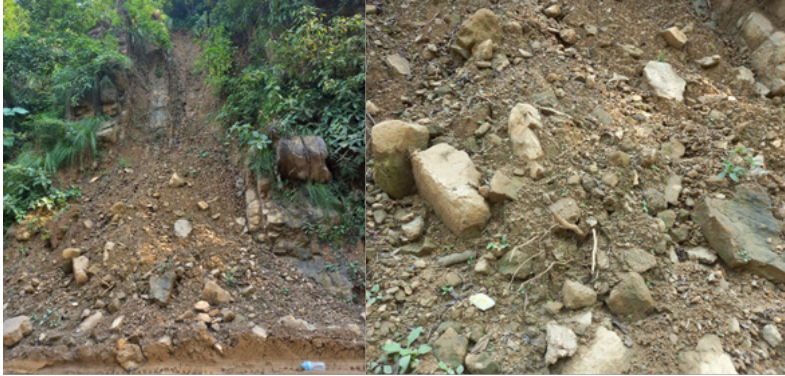
### ***Landslide 12***

Type: Debris Flow

Slope: 65-70 degrees

Volume= 444m<sup>3</sup>

Deposited materials: mud, debris, rocks of sizes up to 0.4m

Impacts: Temporary obstruction of the road

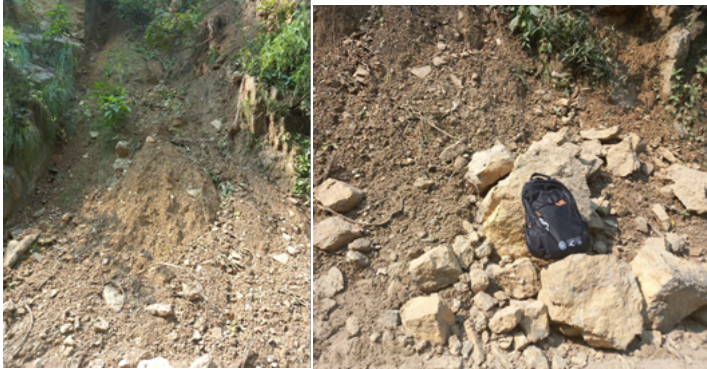
### ***Landslide 13***

Type: Debris Flow

Slope: 65-70 degrees

Volume= 369.75m<sup>3</sup>

Deposited materials: mud, debris, rocks of sizes up to 0.4m

Impacts: Temporary obstruction of the road

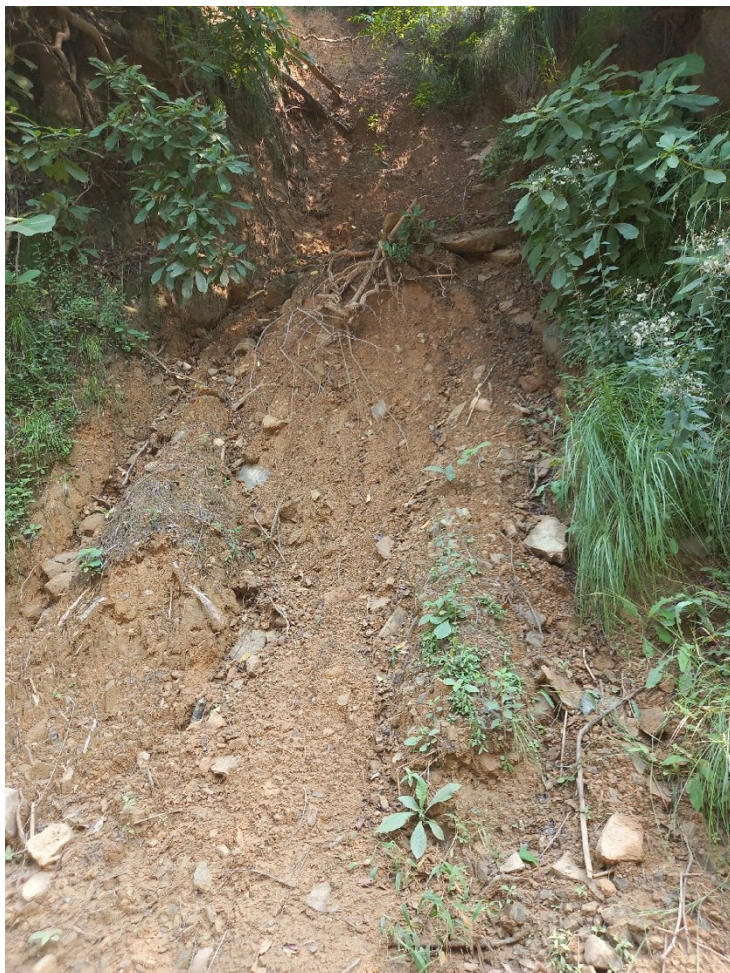
### ***Landslide 14***

Type: Debris Flow

Occurrence: 2023 monsoon; looks recent (local interview)

Volume= 356.7m<sup>3</sup>

Deposited materials: mud, debris, small rocks

Impacts: Temporary obstruction of the road

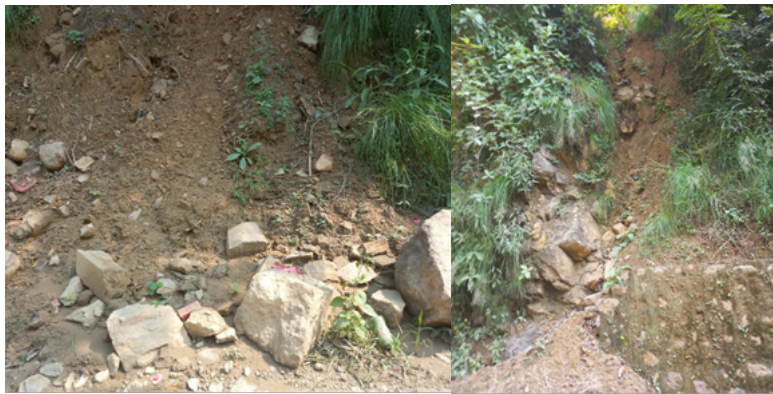
### ***Landslide 15***

Type: Debris Flow

Slope: 62 degrees

Volume= 252m<sup>3</sup>

Deposited materials: mud, debris, rocks of sizes up to 0.6m

Impacts: Temporary obstruction of the road

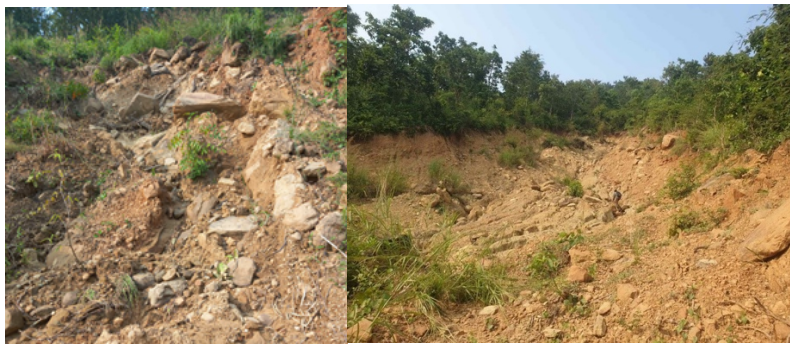
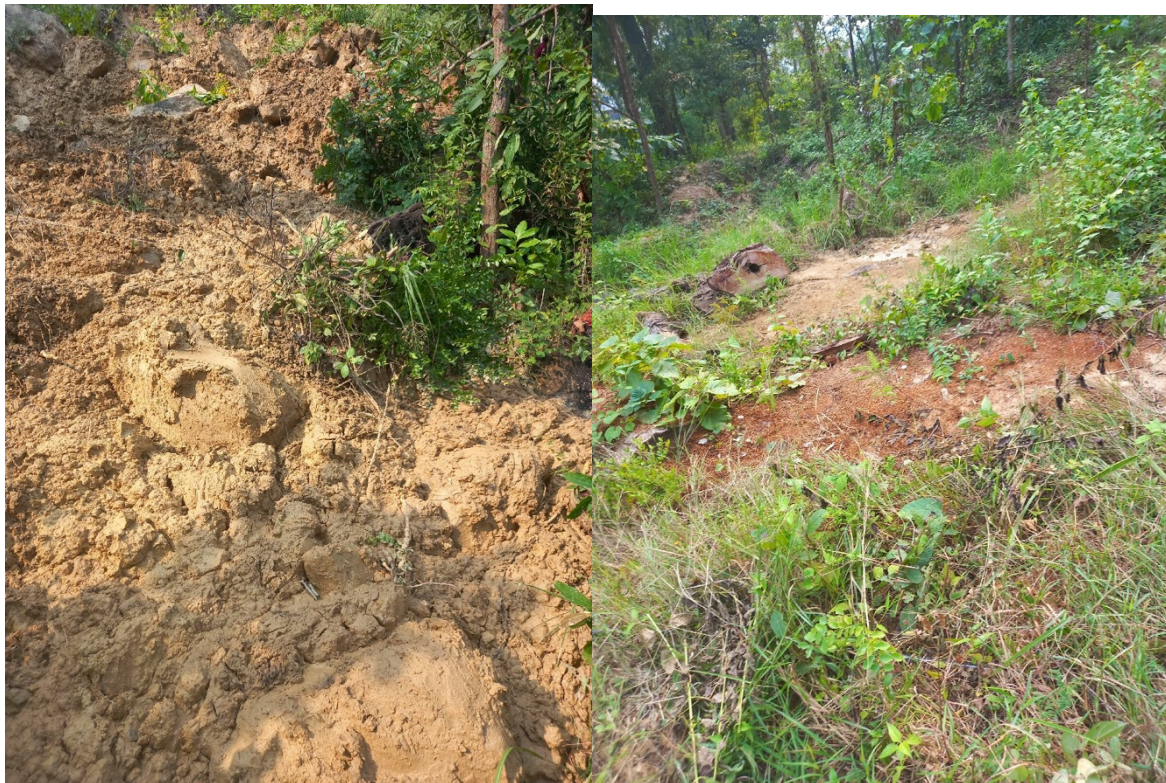
### ***Landslide 16***

Type: Rotational slide

Occurrence: 2022-2023 monsoon; condition exacerbated during 2023 rainfall (local interview)

Volume= 30530m<sup>3</sup>

Deposited materials: mud, debris, rocks of sizes up to 1.2m

Impacts: Caused drinking water pipeline burst, extreme rainfall brought debris towards the houses

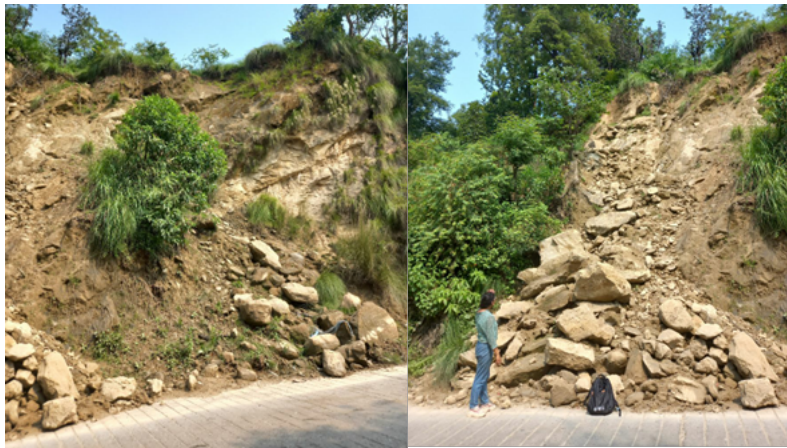
### ***Landslide 17***

Type: Translational slide

Slope: 65-70 degrees

Volume= 972m<sup>3</sup>

Deposited materials: mud, debris, rocks up to size of 0.6m

Impacts: Temporary obstruction of the road; locals had to remove deposited rocks from the road

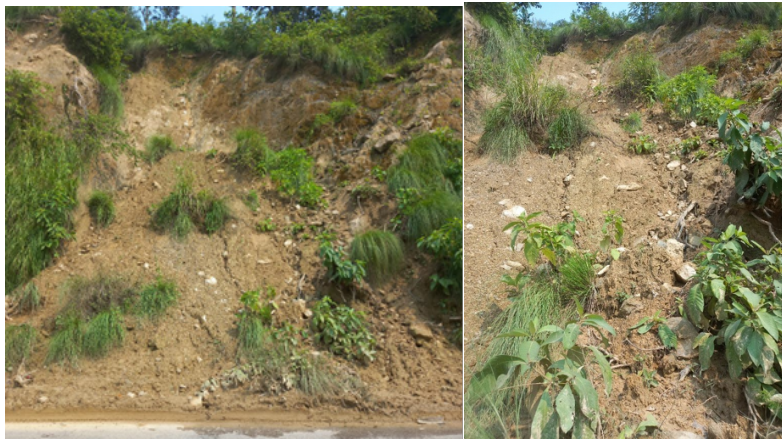
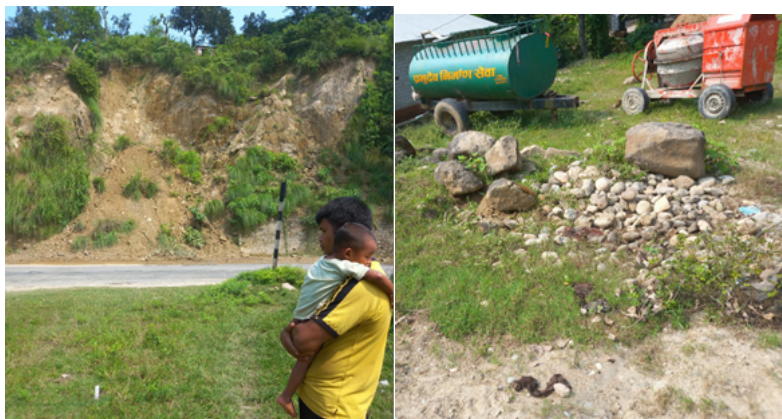
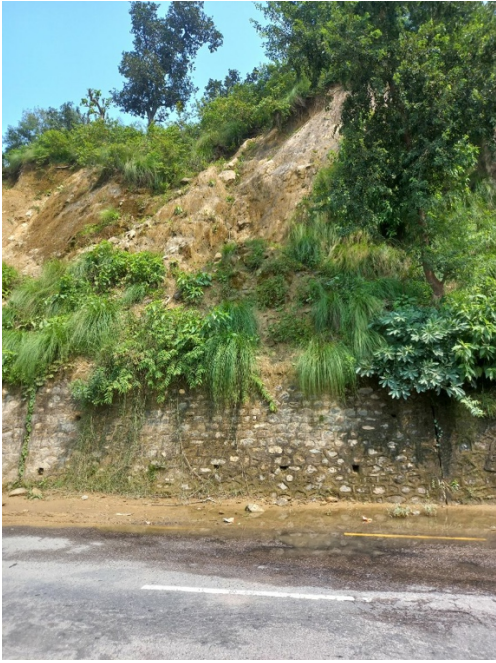
### ***Landslide 18***

Type: Translational slide

Occurrence: old landslide, condition worsens during every extreme rainfall events (local interview)

Deposited materials: mud, debris, rocks up to size of 0.4m

Impacts: Temporary obstruction of the road; locals had to remove deposited rocks from the road; retaining structure built last year
